## Maryland Historical Trust State Historic Sites Inventory Form

1. Nam	e (indicate	preferred name)		
historic			•	
and/or common	ROBERT A. I	MARTIN HOUSE		
2. Loca	ition			
street & number	251 Pleasan	t Valley Road	· 	not for publication
city, town	Westminster	XX_ vicinity of	congressional district	Sixth
state	Maryland	county	Carroll

The Robert A. Martin House is a two-story, three bay SUMMARY: by two bay farmhouse on a fieldstone foundation. It is constructed of frame with brick insulation, although some of the exterior walls may be of log (according to oral interviews), and the exterior is currently covered in aluminum siding. It has a gable roof covered in standing seam sheet metal with rebuilt brick chimneys at each gable end. three bay main facade faces south and has a central entrance although the door was recently replaced by the present owner. Other bays on the main facade and on the east and west gable ends have tall six-over-six sash windows. The north facade contained a double-tiered porch that has been partially The architecture of the interior is fairly uniform in detailing from the late 19th century, including door moldings, window frames and box locks with 1880s p

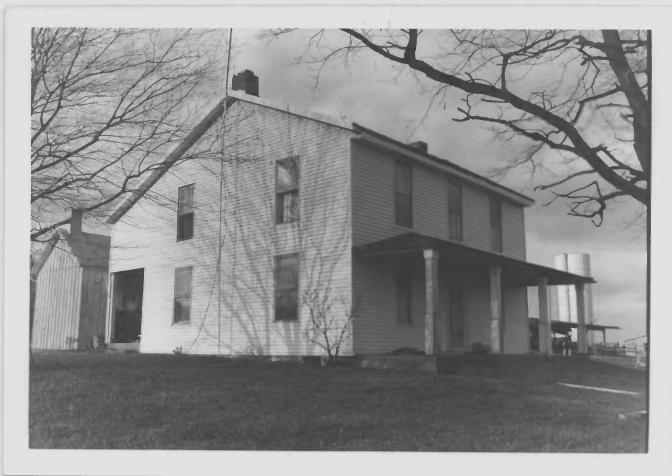
5. Md. Hist. Trust, Annapolis, Md 6. S & W elev (camera fac NE) 7. 1/11

The farmhouse is a two-story, three bay by two bay structure on a fieldstone foundation. From renovation work done by a Robert A. Martin where the structure was exposed, it is constructed of frame with brick insulation. This was a popular framing technique in this region during the late 19th century. However, some of the exterior walls may be of log, according to an oral interview with Margaret B. Jordan who lived in the house from 1906 to 1919. She recalls that a log wall was exposed when putting in the stove. The exterior is currently covered in aluminum siding.

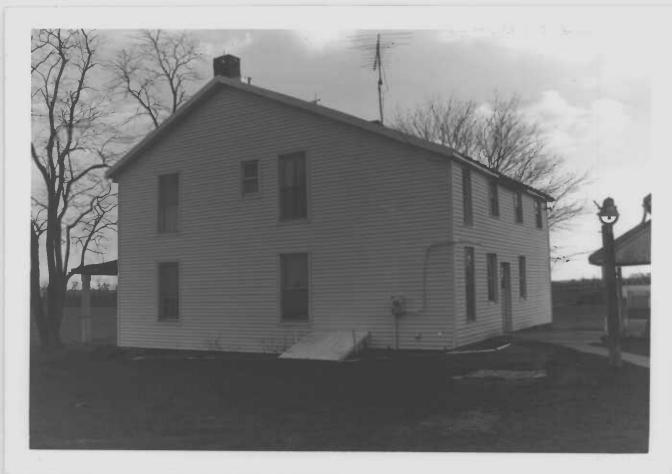
- CARR-1283 ROBERT A. MARTIN HOUSE
- Carroll County, Maryland
- Joe Getty
- November 1986
- Md. Hist. Trust, Annapolis, Md. E & N elev (camera fac sw) 2/11

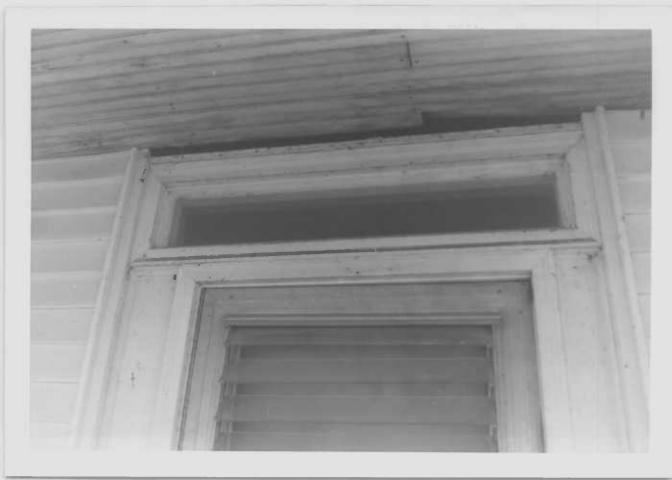
- CARR-1283 ROBERT A. MARTIN HOUSE
- Carroll County, Maryland
- Joe Getty September 1986
- Md. Hist. Trust, Annapolis, Md
- - S elev. -- transom detail 3/11

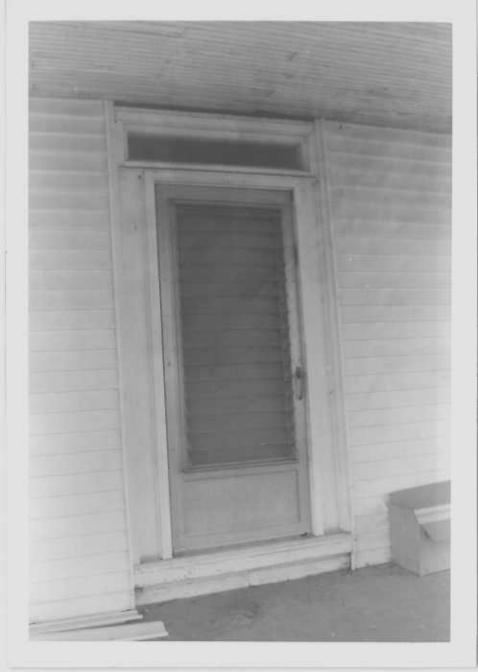
2. Carroll County, Marylan
3. Joe Getty
4. September 1986
5. Md. Hist. Trust, Annapo
6. S elev. -- front door

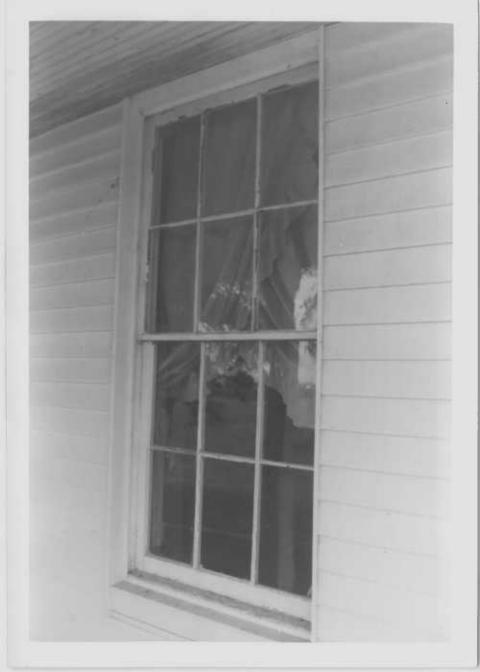
- CARR-1283 ROBERT A. MARTIN HOUSE
- Carroll County, Maryland
  - Joe Getty September 1986
- Md. Hist. Trust, Annapolis, Md.
- S elev -- window frame
- 7. 5/11

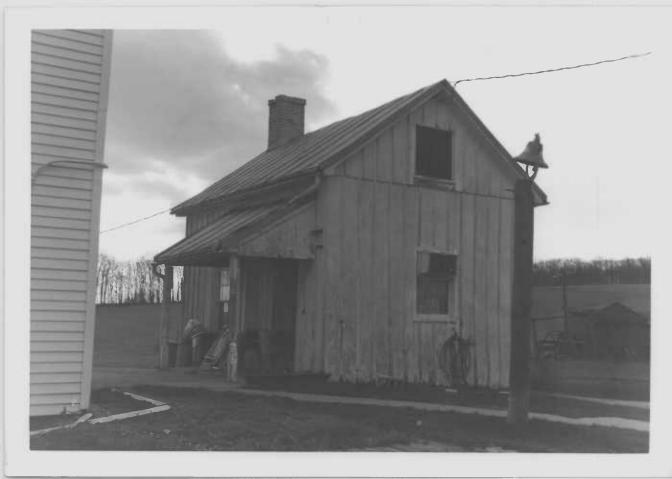
- CARR-1283 ROBERT A. MARTIN HOUSE
- Carroll County, Maryland
- 2. Carroll County, Marylan
  3. Joe Getty
  4. November 1986
  5. Md. Hist. Trust, Annapo
  6. Washhouse, s & e elev.
  7. 6/11 Md. Hist. Trust, Annapolis, Md.

dimensions 14 X 20 feet. It is constructed of frame on a fieldstone foundation and has a gable roof coveered in standing seam sheet metal. The south elevation faces the farmhouse and has a door, six-over-six window, and a one-story porch with shed roof. The east elevation has a three-over-six sash window and a six-pane window in the gable. The north elevation has a six-over-six sash window and the west elevation is unfenestrated. A brick chimney rises from the peak of the roof at the west gable end.

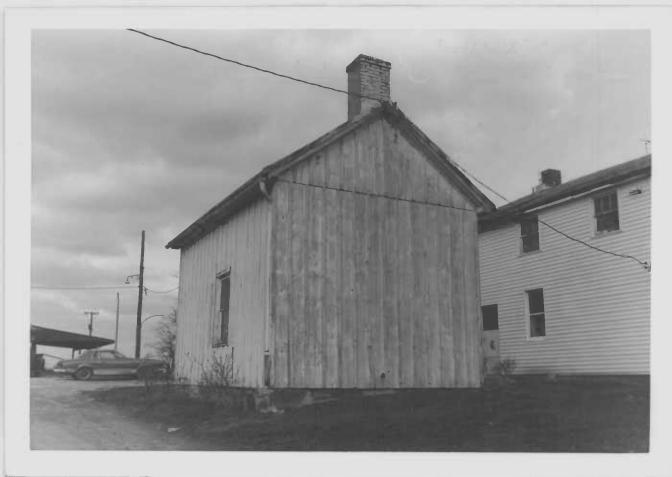
- 1. CARR-1283 ROBERT A. MARTIN HOUSE
- 2. Carroll County, Maryland
- Joe Getty
- 4. November 1986
- 5. Md. Hist. Trust, Annapolis, Md.
- 6. Washhouse, n&w elev
- 7. 7/11

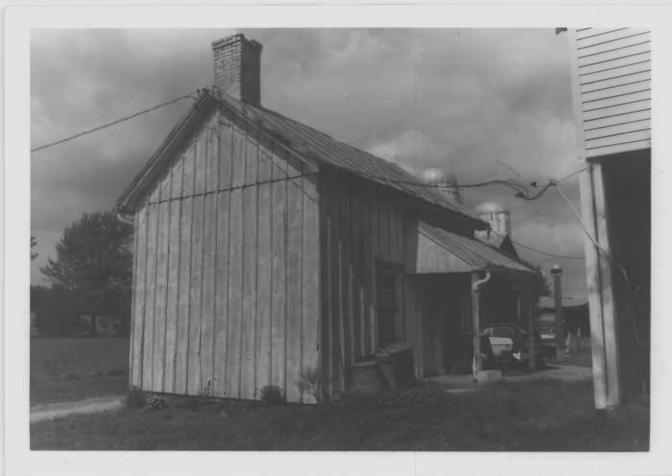
- . CARR-1283 ROBERT A. MARTIN HOUSE
- Carroll County, Maryland
   Joe Getty
- 4. September 1986
- 5. Md. Hist. Trust, Annapolis, Md.
- 6. Washhouse, S & w elev 7. 8/11

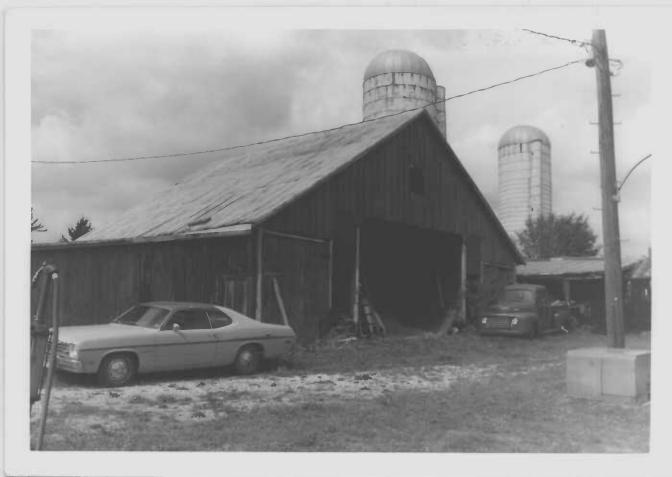
- CARR-1283 ROBERT A. MARTIN HOUSE
- Carroll County, Maryland
- Md. Hist. Trust, Annapolis, Md
- 2. Carroll County, Marylan
  3. Joe Getty
  4. September 1986
  5. Md. Hist. Trust, Annapo
  6. Wagon shed, S & w elev 7. 9/11

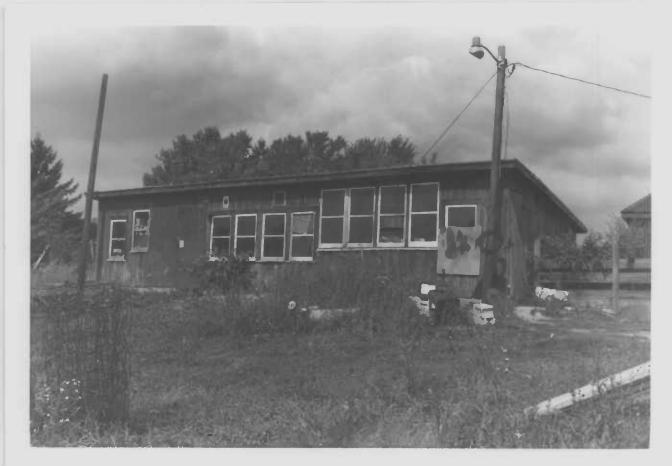
- CARR-1283 ROBERT A. MARTIN HOUSE
- Carroll County, Maryland Joe Getty
- September 1986
- 5. Md. Hist. Trust, Annapolis, Md. 6. Chicken house, W & S elev
- 10/11

North of the washhouse is a small complex of domestic buildings. There is a frame chicken house with a shed roof. The windows of the chicken house, which face west, have been replaced. There is also a board-and-batten smokehouse built about 1975.

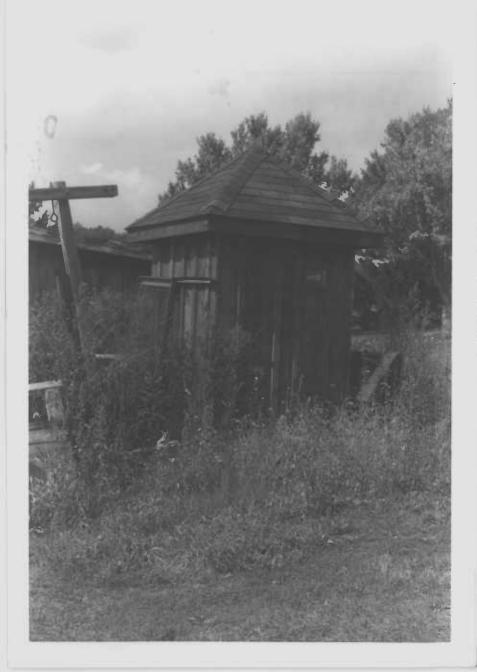
- CARR-1283 ROBERT A. MARTIN HOUSE
- Carroll County, Maryland
- Joe Getty
- September 1986
- 2.34.56.7. Md. Hist. Trust, Annapolis, Md.
- Smokehouse, W & S elev
- 11/11
